# Manhole Inspection Summary

Manhole # S45KK\_036MH

Insp Date: **4/16/08 11:08 AM**

**Location** Address: **E Lanvale St**

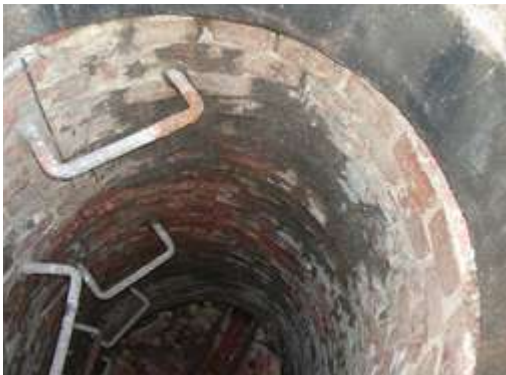
Defect 2

Infiltration: ☐ None ☐ Joint ☐ Cracks ☐ Mortar ☐ Roots ☒ **Wall**

Infiltration

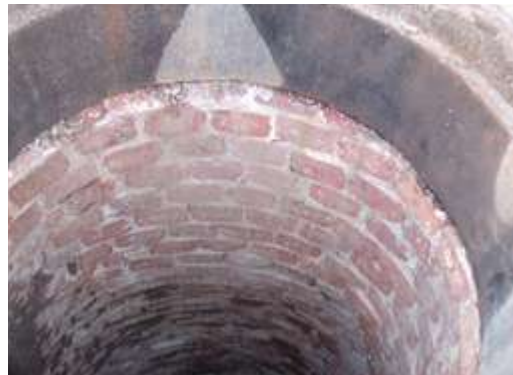
Defect 1

**Frame** Offset: **2** (in.) Condition: ☐ Sound ☐ Cracked ☒ **Leaks**

Frame Leaks

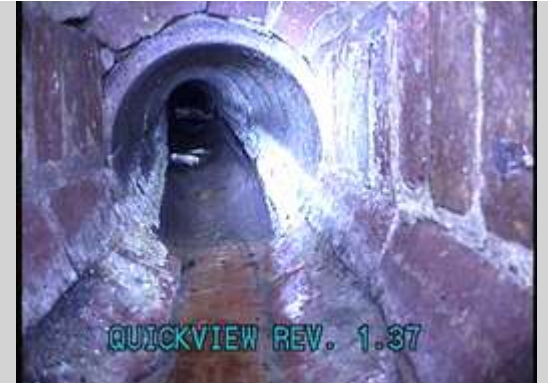
12 O'Clock Outflow

8 in. Circular Gravity Sewer  
Pipe Out @ 12 O'Clock

Pipe Height: **8.4** (in.) Rod and Bar (Angled)  
Pipe Material: **Clay** ☐ Pipe Lined  
Invert Depth: **10.30** (ft.) Flow Characteristics: **Slow**  
Deposits: ☒ None ☐ Mud ☐ Sludge ☐ Debris ☐ Grease  
Silt Depth: (in.) Deposits Extent:  
Infiltration: **None** Pipe Seal Cond: **Sound**

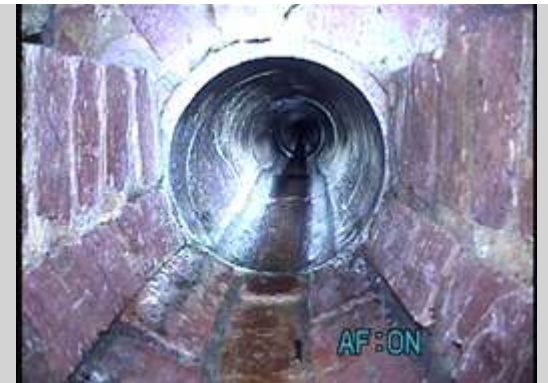
7 O'Clock Inflow

8 in. Circular Gravity Sewer  
Pipe In @ 7 O'Clock

Pipe Height: **8.4** (in.) Rod and Bar (Angled)  
Pipe Material: **Clay** ☐ Pipe Lined  
Invert Depth: **10.20** (ft.) Flow Characteristics: **Slow**  
Deposits: ☒ None ☐ Mud ☐ Sludge ☐ Debris ☐ Grease  
Silt Depth: (in.) Deposits Extent:  
Infiltration: **None** Pipe Seal Cond: **Sound**
